**REPAIRED GLASS COCKPIT
W/WS SYSTEM SAFETY REPORT**

**SYSTEMS SAFETY HAZARDS ANALYSIS REPORT FOR 09/91 - 2/96
CONTRACT NUMBER FO9603-90-D-2217-SD02**

**PREPARED FOR
OKLAHOMA CITY AIR LOGISTICS CENTER
TINKER AFB, OK 73145**

4. TITLE AND SUBTITLE Repaired Glass Cockpit W/WS System Safety Report			5. FUNDING NUMBERS	
6. AUTHOR(S) Richard J. Olson				
7. PERFORMING ORGANIZATION NAME(S) AND ADDRESS(ES) Battelle 505 King Avenue Columbus, Ohio 43201-2693			8. PERFORMING ORGANIZATION REPORT NUMBER Contract FO9603-90-D-2217-SD02

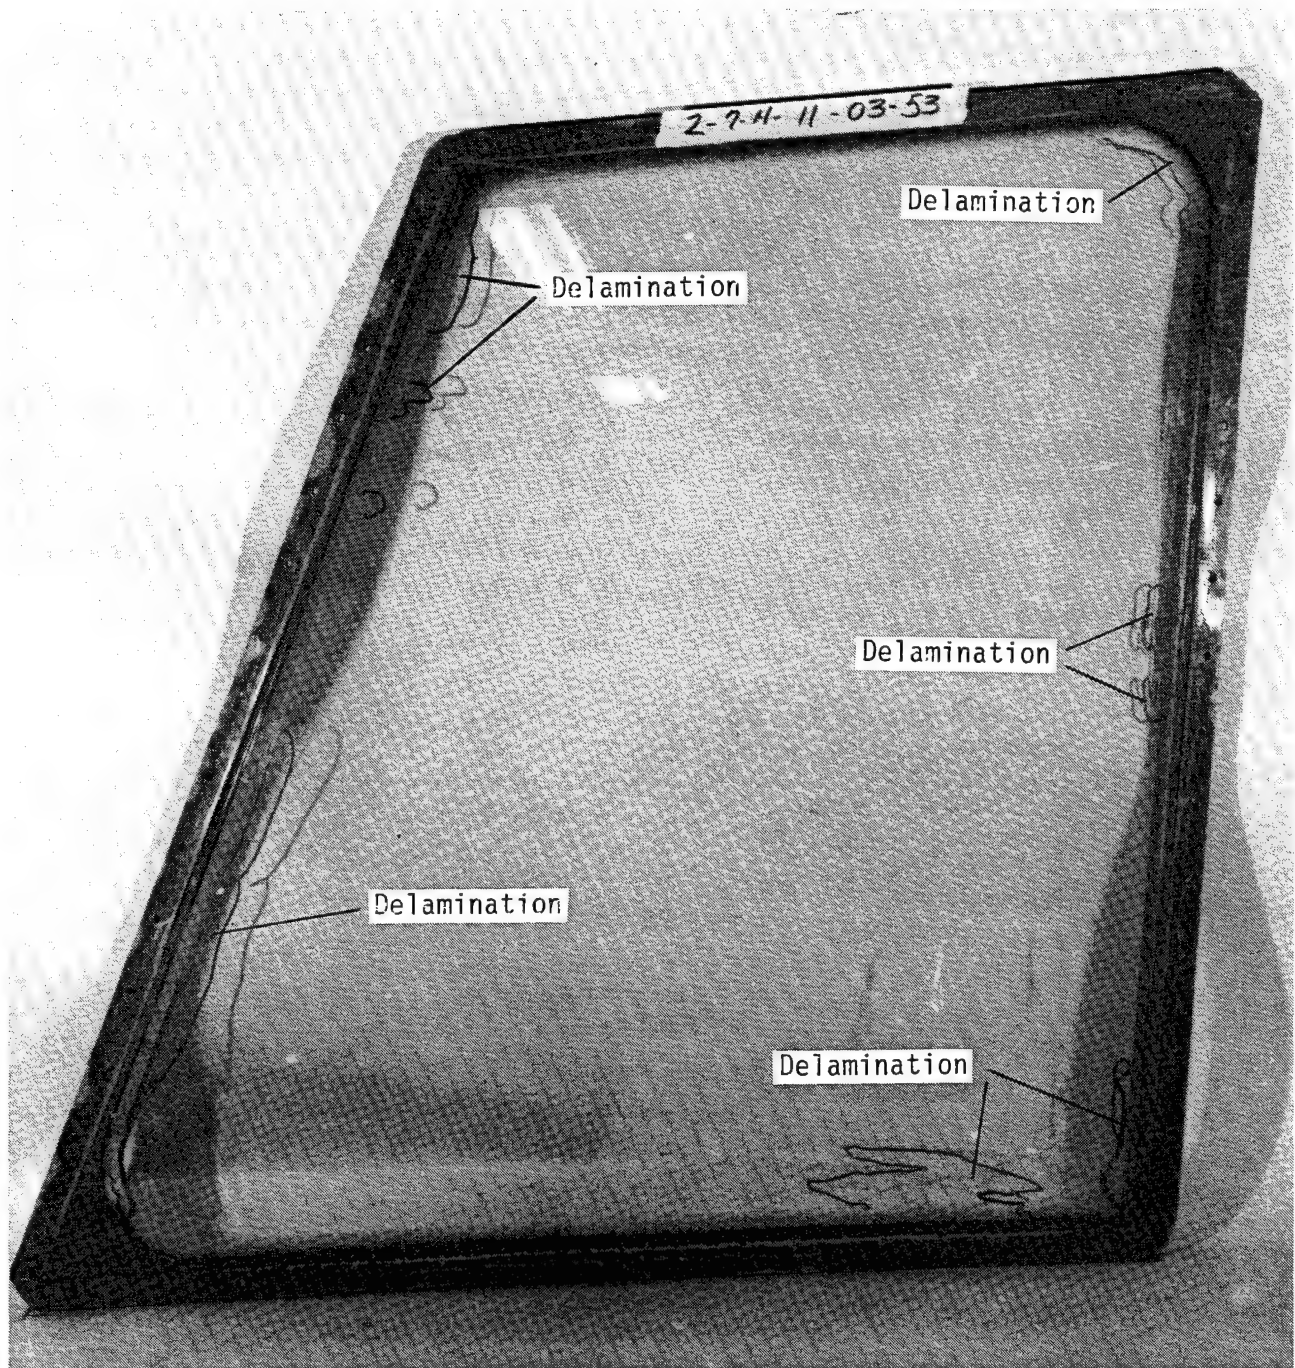
The results of the pressure integrity testing are summarized in Tables 3.13 and 3.14. None of the W/WS, repaired, not repaired, or new, exhibited any catastrophic failures. Some of the repaired W/WS did experience delaminations, and evidence of delamination was detected in the new B-52 W/WS. Figure 3.1 shows the worst delamination that occurred in

any of the W/WS tested. In this figure, the edge of the delamination has been outlined with a black marker. None of the W/WS exhibited delamination that would cause the pilot to be unable to see through the W/WS.

**Figure 3.1 Worst Delamination Observed in all Pressure/Thermal Cycle Tests
(B-52 #1 W/WS, S/N 7-H-11-03-53)**

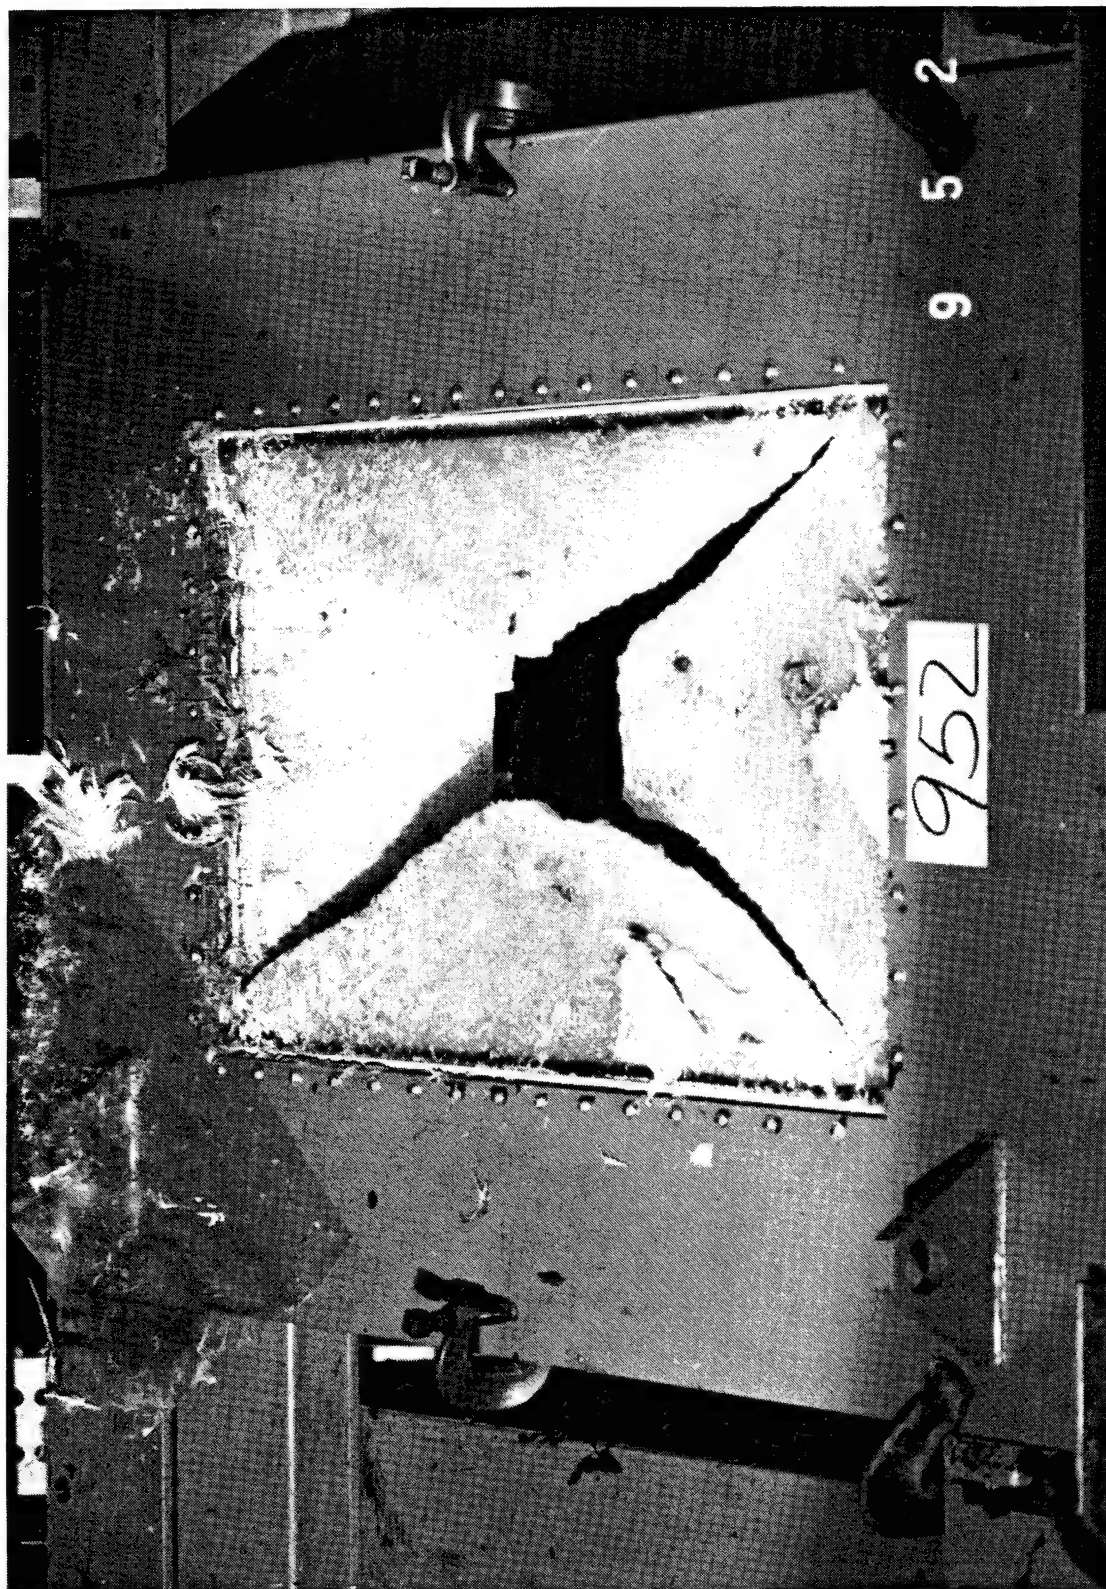
A summary of the bird impact test results is presented in Tables 3.15 and 3.16. A gradation in impact damage is shown in Figures 3.2 to Figure 3.4, ranging from catastrophic failure to only a broken front ply. Other W/WS with similar damage look about the same as these figures.

Figure 3.2 Catastrophic W/WS Failure From a 4-Pound Bird Impact at 250 Knots
(B-52 #1 W/WS, S/N 86-H-04-28-693)

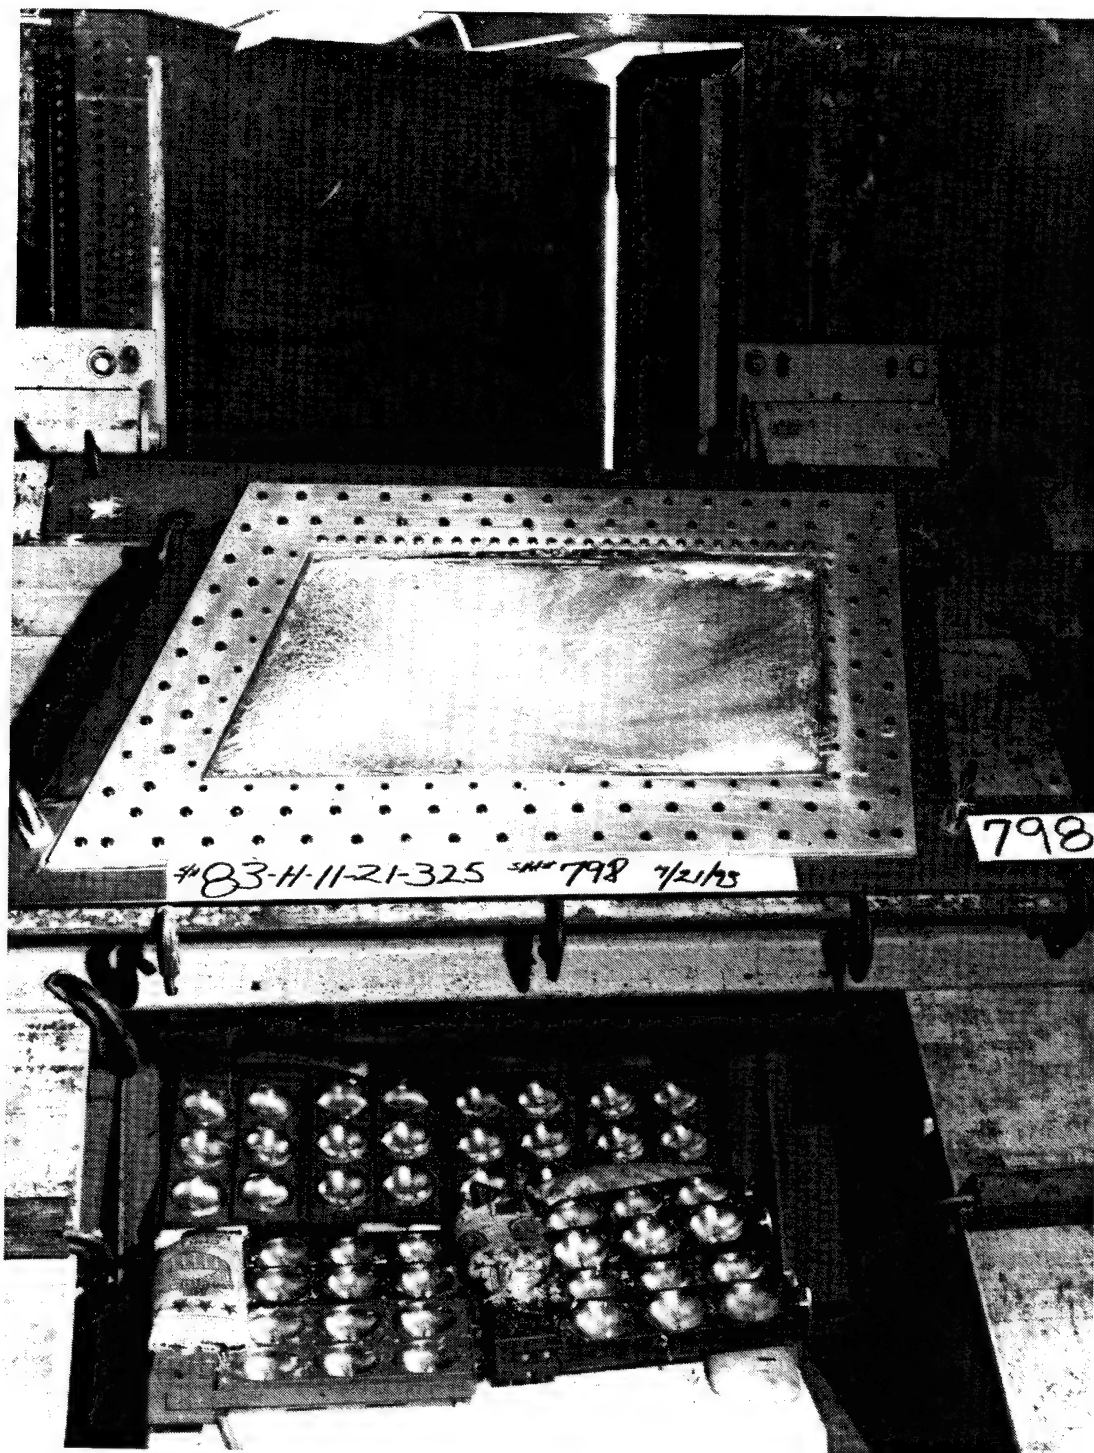
**Figure 3.3 Both Glass Plies Failure From a 4-Pound Bird Impact at 250 Knots
(C/KC-135 #1 W/WS, S/N 83-H-11-21-325)**

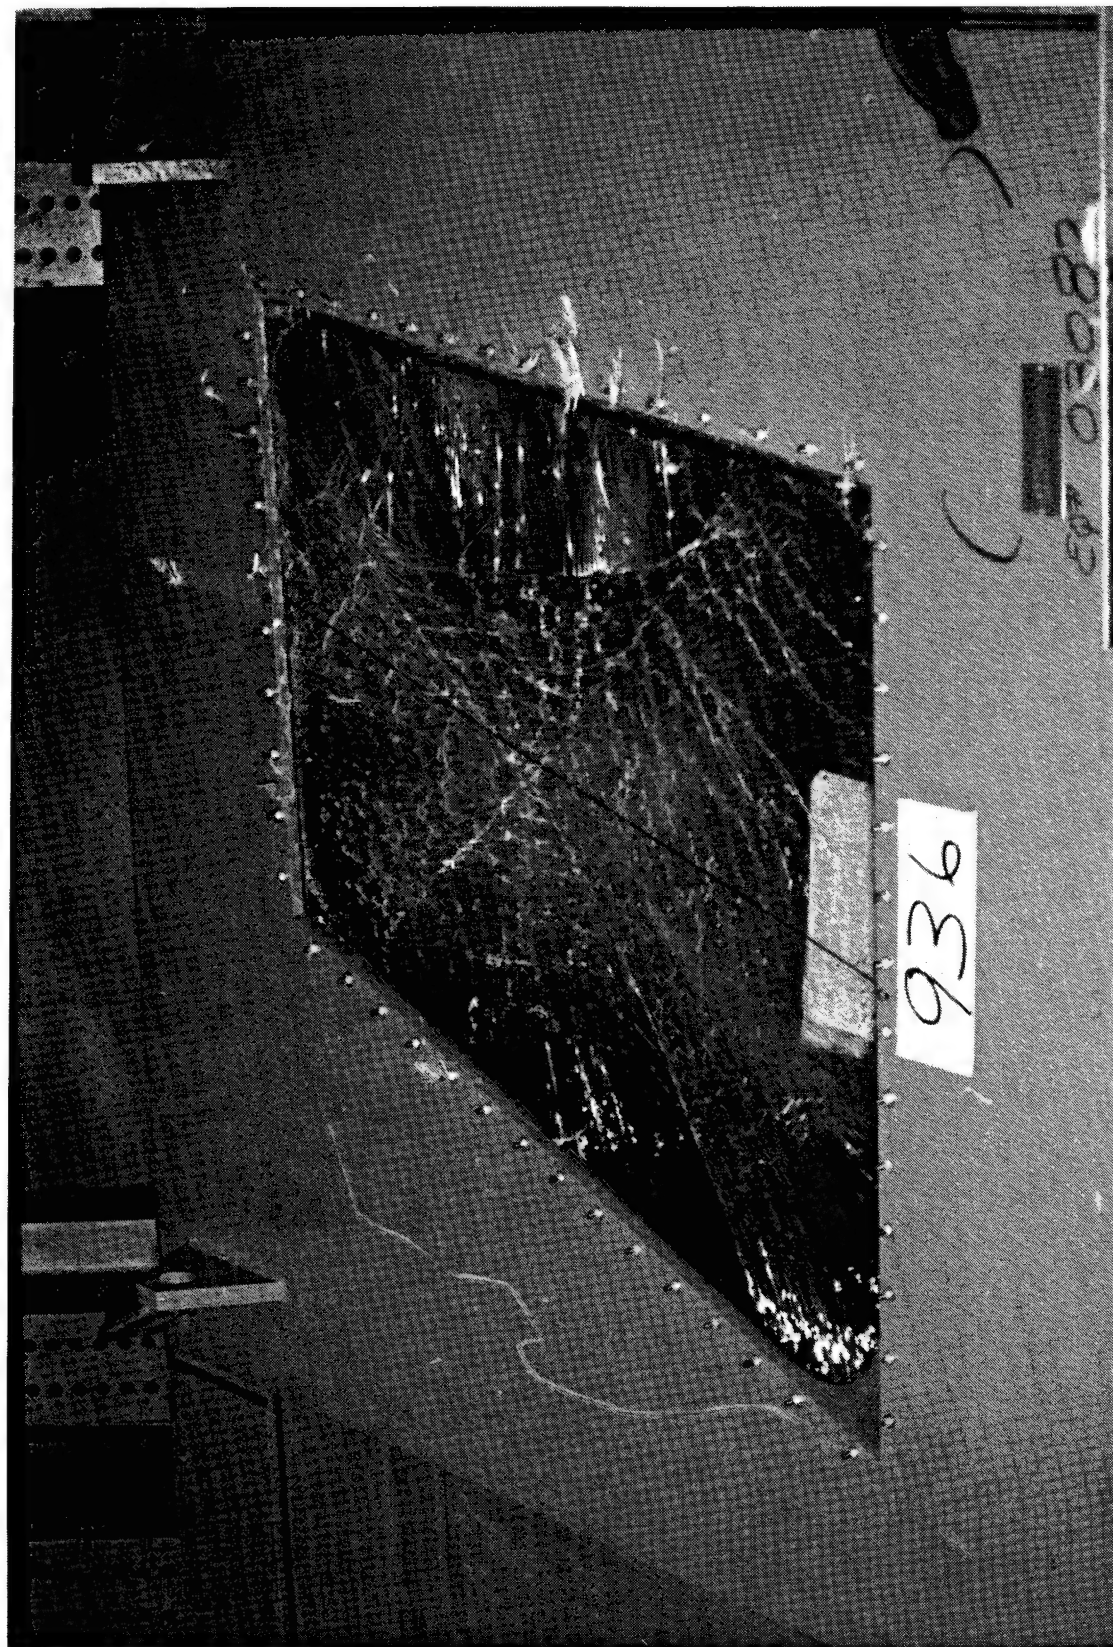
Figure 3.4 Broken Outboard Glass Ply Failure From a 4-Pound Bird Impact at 300 Knots
(B-52 #2 W/WS, S/N 5-H-3-20-17)
